10-Year Facilities Plan

Facility Assessment Report (A Background Report to the Final Study Report)

**City of Pickering
Library Facility Assessments**

A.0 Central Library

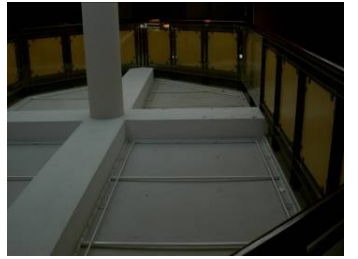
Year 10	Cost	Photo
Install screen around second floor light well.	125,000

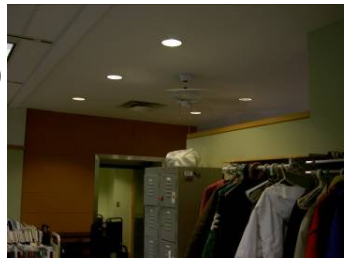
Replace carpet.	80,000	-
Recaulk exterior joints.	40,000	-
Modify HVAC system to increase comfort levels in staff areas.	100,000

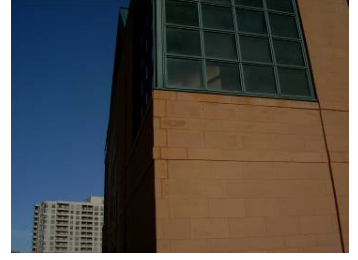
Walls include brick masonry and Arriscraft manufactured stone masonry units. Deterioration of both types of masonry is evident at several locations on the elevations.

Replace emergency and exit lights.	20,000	-
Masonry repairs.	180,000

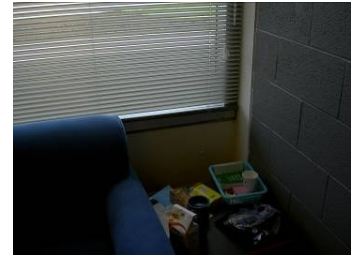
Interior finishes are in fair to good condition and include slate, ceramic floor tile and carpet. Wall finishes include painted drywall in fair condition. Locations in staff areas of the library are worn due to impacts from book trolleys. Staff are considering installation of wainscot to increase the durability of the walls at these locations. Ceilings include lay-in acoustic tile, acoustic absorption panels and painted gypsum board. Lay-in tile panels in several locations are stained due to prior roof leaks which have since been repaired. Replacement of the tiles is in process. Staff report that water infiltration from roof leaks at the west end of the kitchen has also resulted in the discovery of mold in the cabinetry. Staff is developing a program for removal of the mold and any damaged materials.

Year 5	Cost	Photo
Repair library staff area walls and add wainscot.	25,000

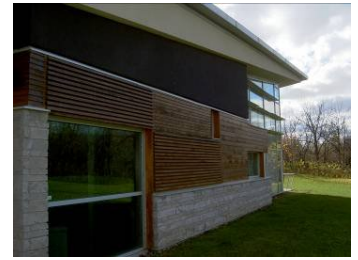
Recaulk exterior.	5,000

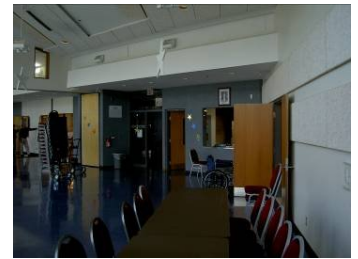
Repaint walls and drywall ceilings. Refinish worn doors.	40,000

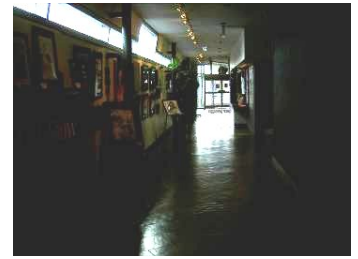
Replace carpeting.	36,000	-
Replace east exterior wall. Include for new east entry vestibule.	450,000

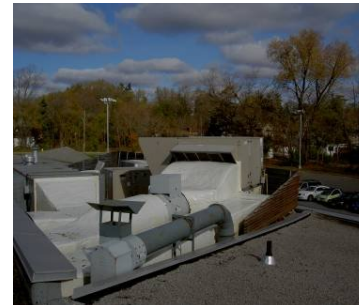
Year 10	Cost	Photo
Recaulk exterior.	5,000	-
Refinish and seal exterior wood strip detailing and panels.	25,000	-
Replace rooftop units and related components	240,000

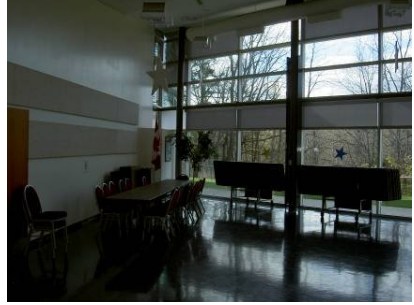
Year 15	Cost	Photo
Recaulk exterior.	5,000	-
Refinish and seal exterior wood strip detailing and panels.	25,000	-
Repair doors, windows and replace worn hardware and weather stripping.	40,000

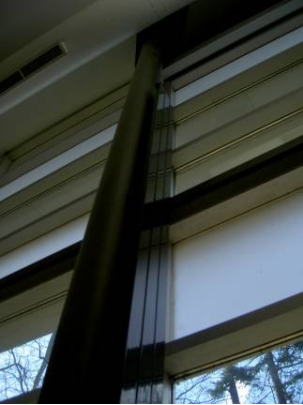
Year 20	Cost	Photo
Recaulk exterior.	5,000	-
Refinish and seal exterior wood strip detailing and panels.	25,000	-
Replace roofing, flashings and related components.	240,000	-
Repaint walls and drywall ceilings.	40,000	-
Replace carpeting.	36,000	-
Replace worn millwork.	45,000	-
Replace worn components of perimeter radiant heating systems.	120,000
